# Research on Treatment of Lining Cracks of Small Section Water Diversion Tunnel

The diversion tunnel is one of the important parts of a water transfer project. The 25 diversion tunnel of the YRDP in the central part of Shanxi Province is located in Shilou County, Luliang City, Shanxi Province. The total length of the tunnel project is 29.13km, of which the main diversion tunnel is 22.81km long. The branch tunnel and the main tunnel are both gate-shaped sections. The branch holes have a clear width of 3.65m and a clear height of 3.2m; the main hole has a clear width of 2.5m and a clear height of 3.24m. Among them, the branch tunnel of the 17# tunnel is 605m long and has a slope of 43.71%, with rail transportation as the concrete transportation method. The surrounding rock is mainly interbedded sandstone and mudstone in the T2er2, which is mainly the type IV surrounding rock. According to the design drawings, the strength grade of the lining concrete of the tunnel is C25, the impermeability grade of the rock tunnel section is W6, the frost resistance grade is F50, the longitudinal reinforcement for the type IV surrounding rock is  $\Phi 10@200$ , the circumferential reinforcement i

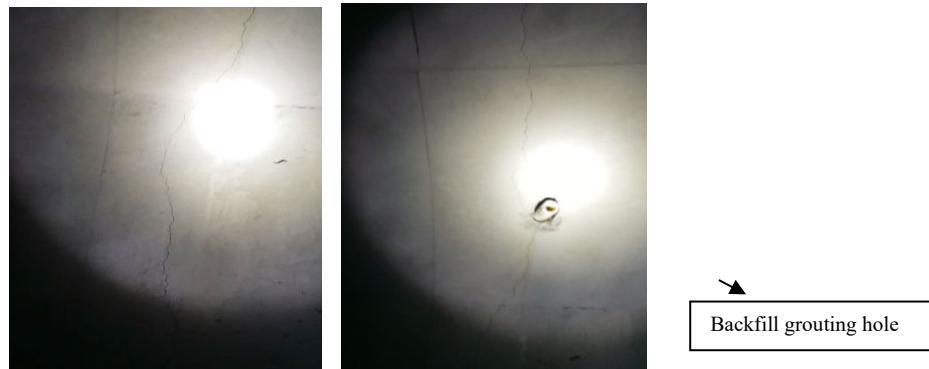
The lining concrete cracks of 17# tunnel generally appeared 7 days after the completion of concrete pouring. The cracking location is generally at the side wall close to the bottom plate. As time goes by, the cracks gradually extended to the top, and showed a circular distribution characteristic in about 30 days. The crack development pattern is shown in Figure 1 and Figure 2.

Figure 1: Cracks of the side wall Figure 2: Cracks of the vault

After the cracks were discovered, the crack width and depth were measured by using a crack tester. The crack depth is basically between 2cm~5cm, with the maximum depth of about 9cm, and the crack width is mainly between 0.15mm~0.5mm, and the maximum 1mm belongs to surface cracks. The observations of some selected cracks are shown in Table 1.

According to the above theory, the evaporation of the 20% water will cause the concrete to shrink. Each block in the main tunnel consumes about 60 cubic meters of concrete. The evaporation of water in the concrete with the original mix ratio= $60 \times 0.245 \times 20\% = 2.94T$ , and evaporation of water in the concrete with the current mix ratio= $60 \times 0.165 \times 20\% = 1.98T$ , with the evaporation of water reduced by nearly 1T, and the shrinkage reduced significantly. The shrinkage of concrete is possibly a cause of cracks.

After discovering circular cracks in the lining concrete, the supervision and construction unit were organized to take immediate measures. The first measure was to adjust the concrete mix ratio (to reduce the blinding material consumption), that is adjusting the cement consumption from the original  $318\text{kg}/\text{m}^3$  to  $298\text{kg}/\text{m}^3$ . After the adjustment, the frequency of cracks in the concrete poured on site was

significantly reduced, but it was not completely eliminated. After that, the water-reducing agent that meets the requirements was re-selected, the mixing ratio was strictly controlled, the time of template dismantling was extended and the maintenance was strengthened. In view of the fact that the tunnel had been connected and the wind in the tunnel was so strong that the moisture on the surface of the concrete may evaporate faster and may produce shrinkage cracks, a curtain had been installed in the tunnel. After the above measures were adopted, the visible cracks were basically eliminated.

For anhydrous cracks with a width  $\leq 0.2\text{mm}$ , the low-viscosity epoxy resin grout was used for painting and sealing, and the sealing width is 10cm. The material has good adhesion to materials including concrete, and is able to maintain good air tightness and waterproofness under continuous expansion, vibration and temperature changes. With simple construction process, good durability, and non-toxic pollution, suitable for the most of the lining cracks.

For cracks with width  $> 0.2\text{mm}$  and cracks with width  $\leq 0.2\text{mm}$ , polyurethane was used for grouting after polishing. After grouting, the low-viscosity epoxy resin grout was used to paint and seal, and the sealing width is 10cm.

(3) For special cracks, for example, cracks with a width greater than 0.2mm and a large amount of water flow, after the polyurethane grouting was completed, the surface was sealed with a polyurea material, and the sealing width is 10cm.
