# Analysis of Paint Film Cracking on PVC Surface after Secondary Baking

SAIC Volkswagen Co., Ltd., Shanghai, 201805, China

**Abstract:** Two-tone car needs to go through the oven twice, PVC and the film on the PVC surface due to shrinkage difference, secondary baking, paint film will produce cracking problem; the interval between two baking times, ambient temperature and humidity, PVC material and film thickness will affect the cracking situation. This paper analyzes several influencing factors through experiments and solves the problem by taking relevant measures.

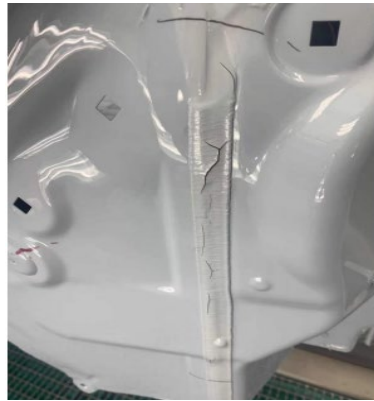
During June and July of each year, the high temperature and humidity environment in the Yangtze River Delta region, with temperatures reaching 35-40°C and humidity reaching 80-100%, will affect the painting construction. For the two-tone body spraying, after the first coat is finished, due to shutdowns, etc., the black roof is unable to complete the spraying and baking in time, and the PVC will absorb moisture in high temperature and high humidity environment. The longer the time, the higher the temperature and humidity outside, the more serious the moisture absorption, and during the second baking process, the PVC surface coating will crack, as shown in Figure 1. [10] This cracking seriously affects product quality and causes a large amount of repair work, and puts higher requirements on the production schedule.

Figure 1: Crack status of paint on PVC surface

Second, for high temperature and humidity weather, if the production stop time exceeds two days, timely completion of the black roof second spray is necessary to reduce the interval between the two bakes. We need to guide the production and solve the problem of cracking of the paint film.

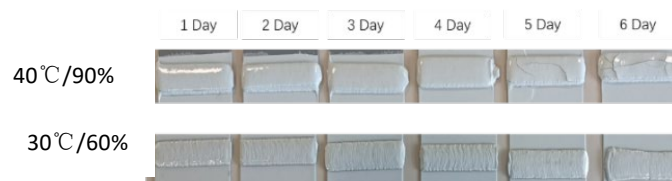
Two samples with a paint film thickness of 110um were placed in a salt spray chamber with different temperature and humidity environments, respectively at 30°C/60% humidity and 40°C/90% humidity for 1-6 days. Then carry out the second baking, and study the impact of temperature and humidity on the cracking of PVC surface paint film based on the cracking status shown in Figure 4. As shown in Figure 4, the PVC surface paint film gradually cracks with the increasing storage time under the temperature and humidity of 40°C/90%, and the cracking becomes more serious. However, under the temperature and humidity of 30°C/60%, the surface of the paint film does not crack during the storage of 1-6 days. The results show that the higher the temperature and humidity, the more easily the PVC surface paint film cracks, and the more serious the cracking becomes with the prolonging of the storage time before the second baking. In the Yangtze River Delta region, in June and July when the weather is high temperature and humidity, if the production is stopped for a long time and the black roof car is not completed with the second coating and baking, PVC will absorb a large amount of water vapor. If spraying is performed after a period of time, it will cause film cracking on the PVC surface, affecting the quality of the car.

Figure 4: Crack status of different temperatures and humidity

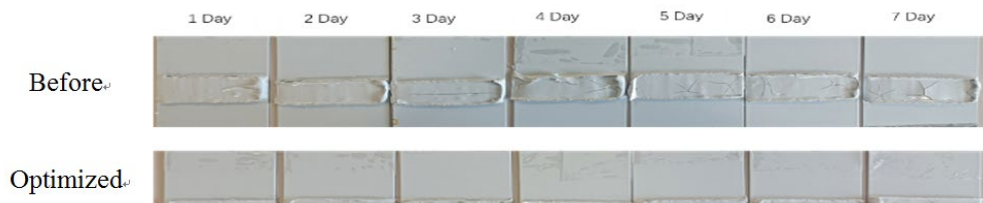
Two PVC formulations were selected to compare their cracking conditions. The test conditions were 40°C/90% humidity, with a residence time of 1-6 days in the salt spray chamber, followed by baking in the oven, and the cracking conditions were evaluated. The specific cracking conditions are shown in Figure 6. As time increases, the paint film gradually cracks, but sample 1 cracks more seriously. Sample 1 is the original formula, while sample 2 is an optimized sample, optimized by reducing the PVC expansion rate. This test confirms that the optimized PVC reduces the PVC expansion rate, which can improve the cracking condition of the PVC surface paint film.

Figure 6: Crack status of different PVC formulations

First, we need to optimize and reduce the expansion coefficient of PVC, reduce the shrinkage and expansion rate of PVC during secondary baking, reduce the difference with the paint film, and effectively reduce the risk of cracking of the paint film.
