Finite element analysis of steel-bonded reinforcement for cast-in-place beamless floor

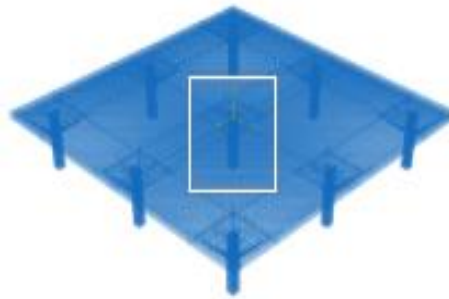
Figure 3: Computing unit

This paper simulates the reinforcement of column caps for beamless floors. There are 9 columns in the model, and only the column caps of the middle columns are reinforced and analyzed. The non-beam floor slab adopts symmetrical restraint on all sides, and the column foot adopts completely fixed restraint. The model is reinforced with three steel plate thicknesses, 3cm, 2cm, and 1cm respectively. The column cap of the beamless floor is reinforced with full section, and the reinforced steel plate extends 500mm in the direction of the column, as shown in Figure 3, Figure 4 and Figure 5.

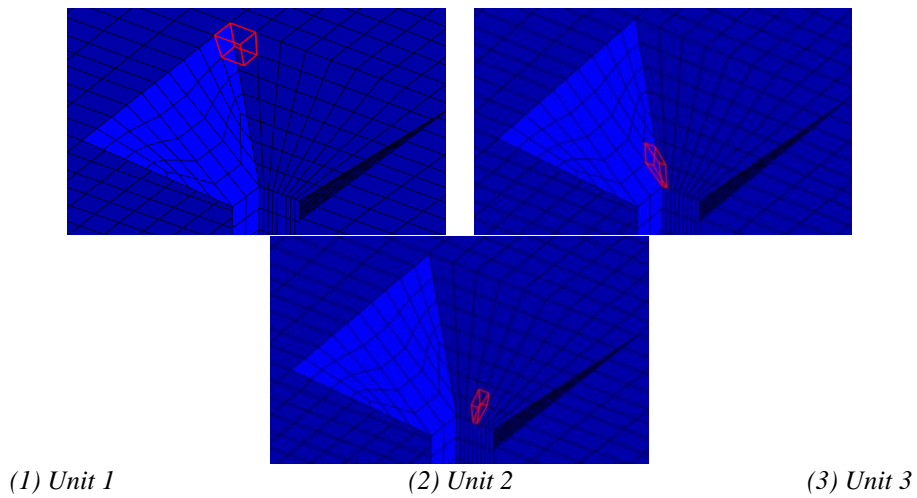
Under the action of 0.04Mpa compressive stress, the stress cloud diagram at the reinforced position of the beamless floor is shown in Figure 8. The comparison results are shown in Table 1.

Figure 8: Unit number and unit position at the column cap

When the thickness of the reinforced steel plate is 3cm and 2cm, the stress of unit 1 is reduced by 59%; the stress of unit 2 is reduced by 41%; the stress of unit 3 is reduced by 32%.

When the thickness of the reinforced steel plate is 1cm, the stress of unit 1 is reduced by 44%; the stress of unit 2 is reduced by 10%; the stress of unit 3 is reduced by 26%.

(3) The steel plate with a thickness of 3cm and a thickness of 2cm have the same reinforcement effect on the column caps of beamless floors, and both are better than the steel plate with a thickness of 1cm. The thickness of the reinforced steel plate is preferably 2cm.

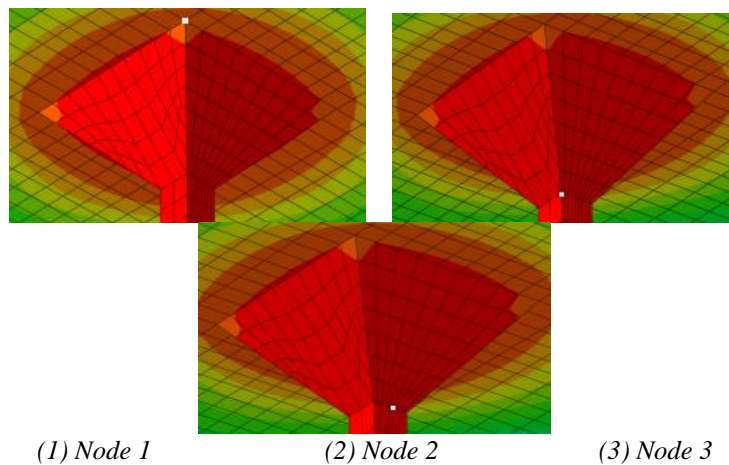
Under the action of 0.04Mpa compressive stress, the vertical displacement cloud diagram at the reinforced position of the beamless floor is shown in Figure 9 below. The comparison results are shown in Table 2.

Figure 9: Node number and node position at the column cap

When the thickness of the reinforced steel plate is 3cm and 2cm, the vertical displacement of node 1 is reduced by 34%; the vertical displacement of node 2 is reduced by 10%; the vertical displacement of node 3 is reduced by 9%.

When the thickness of the reinforced steel plate is 1cm, the vertical displacement of node 1 is reduced by 20%; the vertical displacement of node 2 is reduced by 5%; the vertical displacement of node 3 is reduced by 4%.
