# Analysis of Surface Cracking Defect of 304 Stainless Steel Deep Drawing Products

**ABSTRACT.** Aiming at the transverse cracking defect of 304 stainless steel deep drawing product (rice cooker inner liner) in the process of deep drawing, the martensite content, metallographic structure and mechanical properties were tested. The morphology of 304 stainless steel deep drawing product was observed by scanning electron microscopy, and the components of the defect were analyzed by energy dispersive spectrometer. Based on the experimental results and related research and analysis, it is inferred that the cracking defect of stainless steel inner tank is mainly caused by work hardening in deep drawing process, and small crack is formed due to inclusion shedding in steel, and crack extends further in plastic deformation.

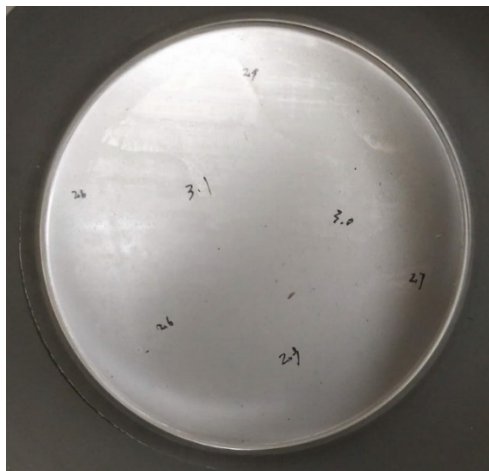
The martensite content at the bottom, side and crack of the sample was detected. The results show that the martensite content at the bottom of stainless steel inner gallbladder is between 2.6% and 3.1%, which is in the normal range (see Figure 2).

Figure. 2 Determination of martensite content in the bottom of stainless steel inner tank

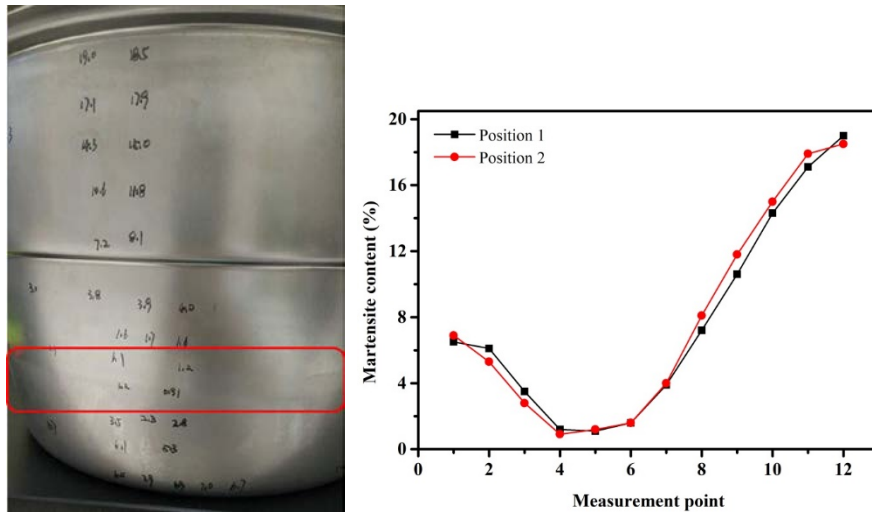
The martensite content in the longitudinal plane of stainless steel inner liner products was measured. The martensite content ranged from 1 to 12 points from the bottom to the top. As shown in Fig. 3, the testing results at two different locations are basically consistent. The martensite content reaches a maximum of 19% at the top of the stainless steel inner gallbladder and a minimum of 1% at the bottom of the gallbladder.

Figure. 3 Determination of martensite content in longitudinal plane of stainless steel inner tank

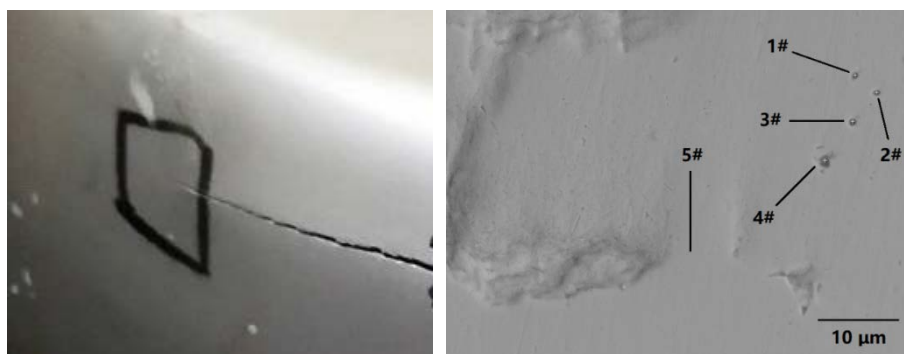
Scanning electron microscopy (SEM) and energy dispersive spectroscopy (EDS) were used to analyze the cracking position. The microscopic analysis showed that there were pits in the defect, and the energy spectrum components showed that there were oxygen, silicon, calcium, magnesium, aluminum and other elements. It was speculated that the inclusion was calcium, silicon and aluminum oxides. The possible cause of cracking defect in stainless steel inner liner is inclusion shedding<sup>[6]</sup>.

Figure. 6 Scanning Electron Microscope Analysis of Cracking Location of Stainless Steel Inner tank

(2) There are pits in the cracks, and the probe results show that the inclusions may fall off. Cracks are caused by inclusions in deep drawing process, and then the cracks develop and extend.
