Study on Shoreline Ecological Environment and Protection Countermeasures-combined with 30 years of image changes of busan coastline as the center

Pukyong National University

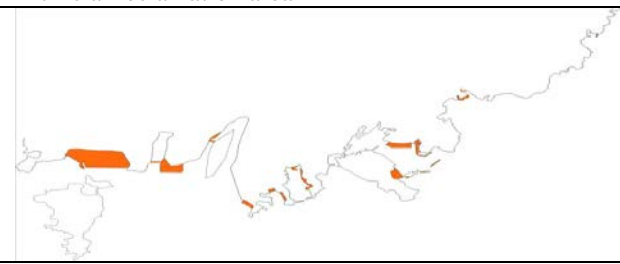
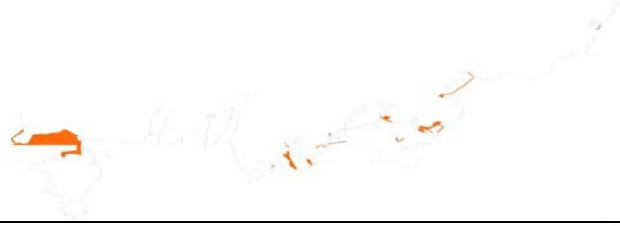
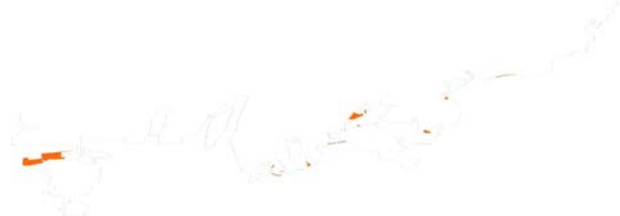
Table 7 Analysis Map of Changes in Coastline Land change (1988-1998, 1998-2008, 2008-2018)

Time	Artificial reclamation area	Construction purpose	Feature
1988-1998

Trading port, Residential areas, Shipbuilding enterprises, Wharf, Breakwater dam,	New
1998-2008

Trading port, Coastal roads, Trading market, Other enterprises, public environment, breakwaters and dams	New
2008-2018

Enterprise expansion, Public environment, Tourist attractions	Expansion

A coastline-land change map was produced based on electronic satellite maps for the four periods of 1988, 1998, 2008 and 2018 (see figure 8). Through the analysis, it can be concluded that the speed of digging and reclamation is faster in 1988-1998 and 1998-2008. In 2008-2018, the land area increased slowly. Combining with the data of Busan coastline change and spatial form analysis, the following strategies of coastline environmental protection are summarized.

Through the analysis of the changes of Busan coastline in the past 30 years, it is shown that the coastline length is reduced and the land area is expanded rapidly. Although the speed of coastline development has slowed down and the ecological environment has improved in recent years, there are still many reclamation and ecological environment problems. Strengthen the management of enterprises, residential areas, tourism services and commerce along the coastline, and prohibit all acts that can cause environmental pollution. Increasing the development of new marine energy and using waves for power generation device design, not only can dissipate waves, but also can carry out the conversion of electric energy, to provide convenience for residents living and landscape lighting.
