Analysis of Weathering Causes and Maintenance Suggestions of Brick Carving in Cai's Ancient Residence

Abstract: Based on the field survey of Cai's ancient residential buildings, this paper finds that the weathering phenomena such as falling off, crisp powder and fading of brick carving decorative components on the exterior wall are mainly caused by environmental factors and marine climate. Based on the distribution and material characteristics of brick carvings in Cai's ancient residence, combined with the analysis of local climate and environmental factors, the author tries to find ways to reduce weathering damage, reasonably repair and maintain brick carving art.

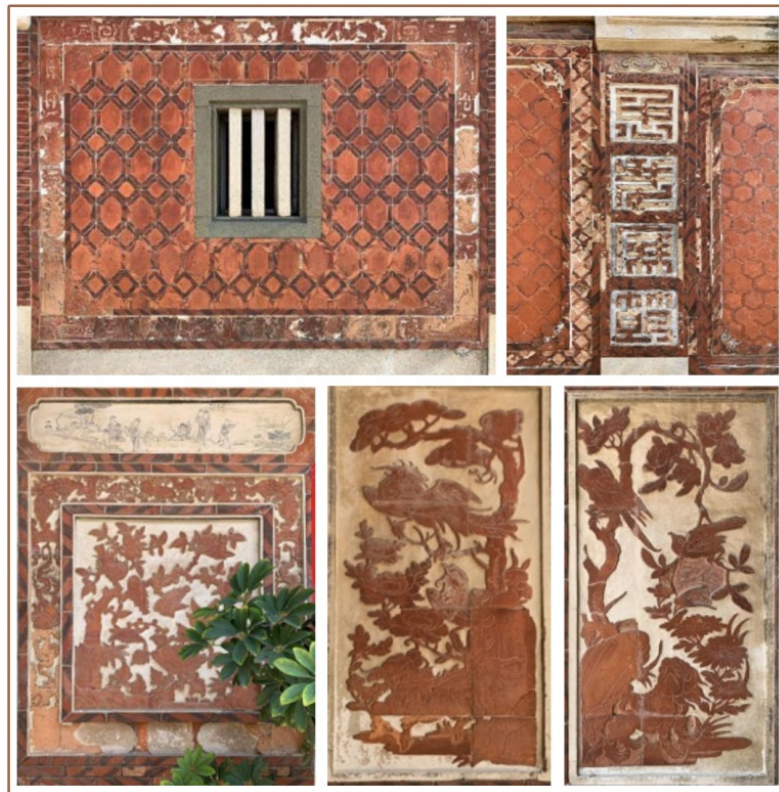
Figure 2: The Weathering Status of Brick Carving

The weathering impact on the brick carving decoration of Cai's ancient buildings is mainly manifested in the fading, powdering, peeling or cracking of local brick surfaces (Figure 2), or the blurring of brick carving lines, which makes it difficult to identify the patterns, and even many traces of artificial carving and painting. The weathering degree of brick carvings in different locations and types is different, and the brick carvings in mirror wall are the most seriously weathered.

4.3. To Make a Reasonable Plan

For the protection of bricks that have been powdery, faded or fallen off, new materials can be used for hydrophobic and reinforcement treatment. For example, the brick carving restoration project of the Imperial Garden of the Forbidden City uses CKYH series organic siloxane resin coating, which combines the heat resistance, aging resistance, adhesion, toughness and water resistance of a variety of polymer materials, and has achieved good experimental results in the protection of cultural relics.

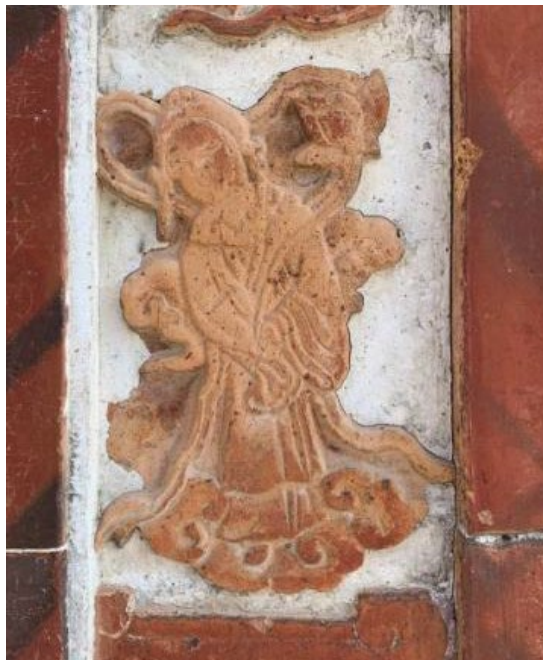
Figure 3: The Gap between Brick Carving and White Background

The "white ash" used as the substrate of brick carving is made from oyster shell kiln after burning and then processed, which is a traditional building auxiliary material in the local area. The composition of lime is similar to hydrated lime and has strong weathering resistance. However, under the influence of environmental factors, there are still many cracks. The structural combination of brick carving components and lime base makes them interact with each other. The falling off or cracking of one side will often reduce the stability of the other side. In the field survey, it was found that many brick carving components have obvious cracks at the joint of brick carving components and white base (Figure 3).

Before repairing cracks, it is necessary to carefully investigate their underlying causes. For example, the cracks formed by different factors such as structure, earthquake and bearing capacity are different. On the basis of the reinforced structure, the proportion of raw materials, color and weathering degree shall be studied. The nature and color of the repair materials and the original components shall be verified by experiments, and then the repair glue shall be used to fill the joints[4].
