# An Analysis on the Thermal Expansion Displacement of Concrete Bridge by 3D Laser Scanning Technology

**Keywords:** concrete bridge, 3D laser scanning, safety inspection, deformation, thermal expansion

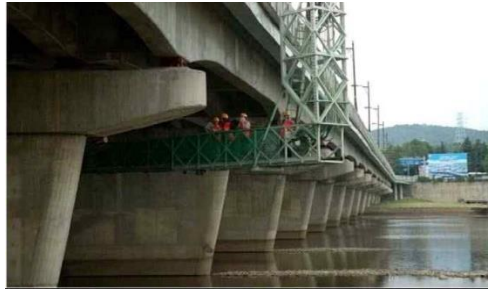
*Fig. 2 Inspection workers standing on temporary scaffolding*

The terrestrial laser scanning technology is the science, which was developed in recent years, because it can provide a 3D coordinated figures including mountain surface, buildings, bridges, human body and human face. This technology has been applied the wildly in deformation monitoring of structural safety inspection due to the high spatial resolution of the acquired data. The inspection workers check the safety status beneath the bridge by counting the number of cracks, measuring the maximum widths and length of crack lines and taking pictures of them. Thus the accuracy and quality of diagnosis report becomes subjective and results differ according to the diligence of the inspection workers. Also, since the bridge inspection is performed outdoors, especially beneath the bridge, there may be the problem concerning the safety of inspection workers. Figure 2 shows the inspection workers standing on a temporary scaffolding in order to inspect the safety status of a real bridge.<sup>5)6)7)</sup>

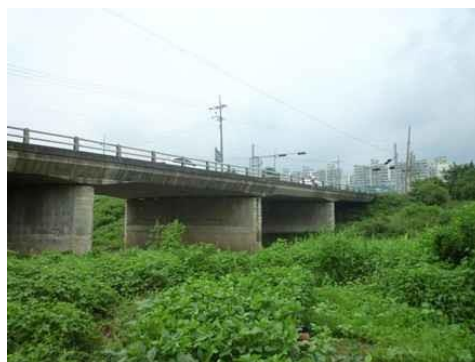
*Fig. 3 View of the Amsogogae Bridge*

Figure 3 shows view of the Amsogogae bridge. The Amsogogae bridge is a concrete bridge, and the bridge total length is 53m, 12m in width. Design load is DB-24TON. Founded in 1996, completed in 1998, are estimated to 14 years old.

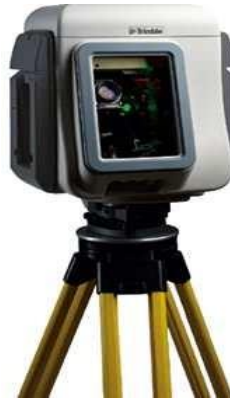
Fig. 4 3D Laser Scanner

In addition, The Trimble GX 3D Scanner includes VISION technology for digital image streaming and capturing. The Figure 4 is shown the 3D scanner head and full picture.
