Failure Characteristics and Seismic Performance Based on Artificial Intelligence and Precast Concrete Shear Walls

ABSTRACT. In order to study the failure characteristics and seismic performance of precast concrete shear walls, the basic failure processes and phenomena of six shear walls were introduced. The length of the reinforcing bar of the prefabricated shear wall specimens with three confinement anchors was 1 times that of the anchorage length of the steel bar. Through analysis and observation, the failure forms of three prefabricated concrete shear walls of YZ12, YZ16 and YZ20 were bending shear composite failure. Because of the effect of the spiral stirrup, the collapse phenomenon was not found in the concrete core area of the compression zone. At the end of the test, the vertical steel bars were yielded. The results show that the most lateral longitudinal bar of YZ12 was broken at the connection between the ground beam and the prefabricated shear wall specimens. In the late test of three contrast cast-in-situ shear walls, the concrete compression zone was completely crushed and the edge longitudinal reinforcement exposed and showed obvious deformation. Therefore, the bindi

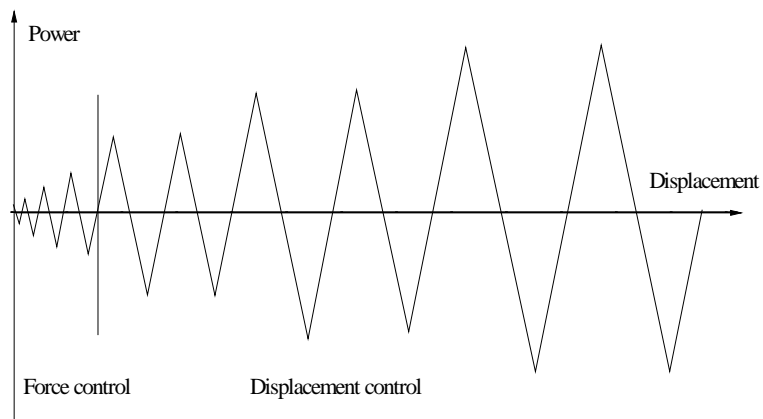
Figure 3 is a loading system diagram, which is loaded with force displacement control.

Figure 3. Loading system

During the test, the critical position of force control and displacement control is determined by observing the hysteresis curve in the actual test. According to the shear bearing capacity of the specimen, the load level is estimated at every step load. The specific value of load at each step is a pre-calculated yield load of 1/5 or 1/6. When performing the displacement control loading, the displacement of each step was taken as the yield displacement of 2.0-3.0 times, and the test was taken as 1.0 times.

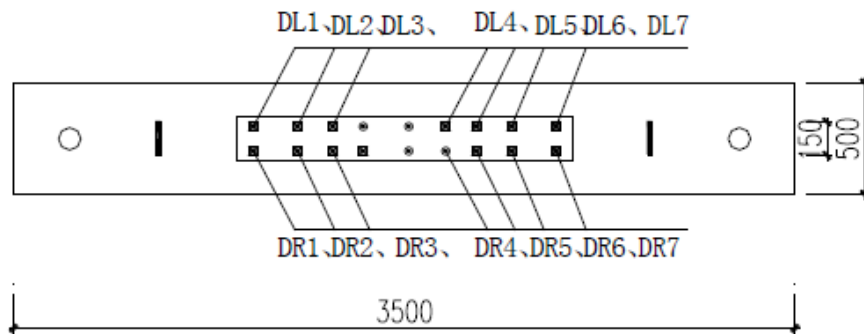
The strain of the steel bar was collected by the strain collector DH3816 in the laboratory. The sticker position of the strain gauge is shown in Figure 5 and Figure 6.

Figure 5. Pasting position of strained strain gage of prefabricated shear wall ground beam

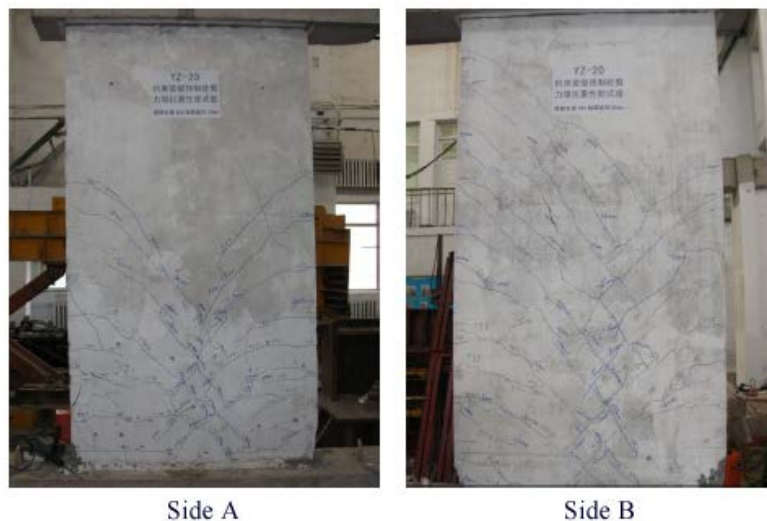
Third, the plasticity and softening stage: when the horizontal load is added to 450kN, horizontal cracks gradually appear around 800mm from the bottom of the test piece. Curved cracks in shear wall specimens are more obvious. In the process of further loading, the bending horizontal cracks constantly rise upwards along the wall height. A horizontal crack is formed at the bottom. The width of the crack is about 1mm. At the same time, the oblique shear slanting cracks in the middle of the center extend to the bottom of the wall. After the displacement control is loaded, the residual deformation of the structure is increasing, and the structure has basically entered the plastic stage. The crack extension speed is accelerated gradually, and the width of the crack increases gradually. The slight collapse was found at the concrete compression zone at the bottom of the specimen. However, the internal bonding of the spiral stirrup is still good, and the phenomenon of slipping or pulling out of the steel bar has not been found. The maximum horizontal load of the actuator in the test room is 1000kN. When the horizontal action is 960kN, the bearing capacity does not decrease obviously. When the load is stopped, the cracks almost fill the whole wall. As a whole, the development and distribution of A and B cracks are not very symmetrical. When interacting with each other, the actuator has an angle with the wall to force the specimen out of the plane. The concrete outside the spiral stirrup is shed, but the core area of the concrete in the compression zone is not damaged (Smith, 2013). However, the ductility coefficient of the specimen is more than 10 at this time, which shows good ductility.

Figure 8. The overall diagram of the YZ20 test piece

First, the elastic phase: the actuator on the top beam is negatively loaded with 300kN. The first horizontal crack appears at the bottom of the wall of the specimen far away from the edge of the actuator. The length of the crack is about 200mm. When the 300kN is loaded forward, the first horizontal crack appears at the bottom edge of the side of the actuator. The length of the crack is about 150mm. At this time, although both sides have curved horizontal cracks, there are no residual deformation when the horizontal load is returned to zero. It shows that the structure is still in a linear elastic phase (Nicolaidis, Kanellopoulos, Savva & Petrou, 2015).

Second, elastic-plastic stage: when horizontal load is added to 350kN, horizontal cracks appear at 500mm at the bottom of the specimen, and gradually extend to the middle part of the wall. The horizontal cracks are found at the bottom of the wall. Its extension length is about 400mm. At this time, the cracks on both sides of the shear wall specimens begin to extend evenly. When the horizontal load is back to zero, the structure has the non-recoverable residual deformation, and it can be seen from the

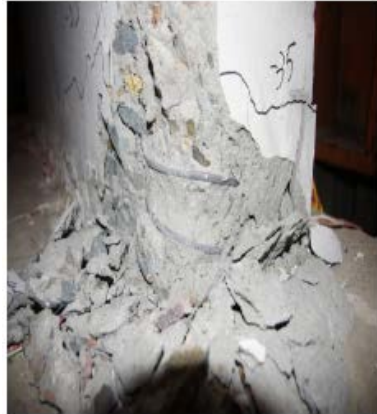
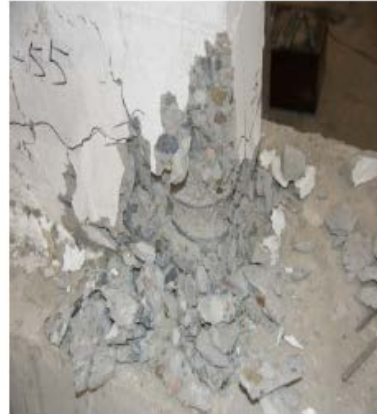
Figure 9. Concrete in the compression zone at the later stage of YZ20

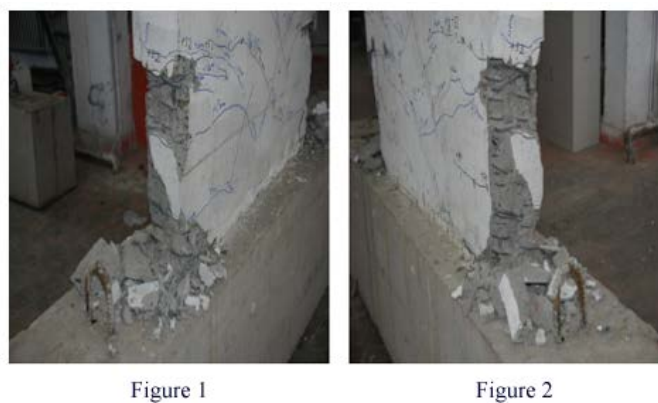
Figure 11. Concrete in the compression zone at the later stage of YZ16

erated gradually, and the crack width is gradually increased. At a distance of 500 mm from the bottom, the main crack of the specimen appeared. With the gradual increase of horizontal load, the crack width becomes more obvious. The maximum crack width is 17mm. The concrete compression zone outside the spiral stirrups at the bottom of the specimen was crushed. When the main cracks through, the bearing capacity still did not decline. However, the width of the main crack is still increasing at this moment, so safety is considered and the test is stopped. The cracks are almost covered with 2/3 walls, and the concrete outside the compression zone is detached. The internal parts of the spiral stirrup have not been destroyed. It is still firmly "wrapped" in the force longitudinal tendons of the dark column. At this time, the ductility coefficient of the specimen is about 6 and the ductility is good.

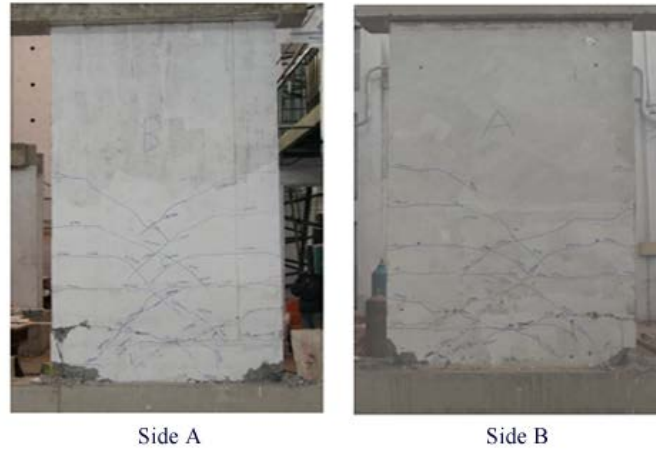
Third, the stage of plastic and softening: after the loading of displacement control, the residual deformation of the structure increases continuously. The structure has entered the plastic stage. The crack extension speed is accelerated gradually, the width of the crack increases gradually, and the maximum width of the main crack is 10mm. When the test was made to the plastic stage, a "slamming" sound showed that the steel was broken. The bar breaking place is the connection between the wall and the ground beam, and there is no phenomenon of pulling out the steel bar inside the spiral stirrup. The crushing phenomenon was found in the concrete compression zone outside the spiral stirrups at the bottom of the specimen. When the main crack passes through in the later stage of the experiment, the bearing capacity tends to decrease (Zhang, Guo & Li, 2013). When the horizontal load drops to 85% of the ultimate load, a significant drop has occurred and the test is stopped. The cracks are almost covered with 2/3 walls, and the concrete outside the compression zone is detached. The most lateral vertical longitudinal tendons are broken and the other vertical longitudinal tendons have yielded. After the test, the most lateral vertical longitudinal tendons were broken at the root. The obvious damage was not found inside the spiral stirrup. The ductility coefficient of the specimen is about 8, and the specimen has a good ductility.

Figure 12. The overall diagram of the YZ12 test piece

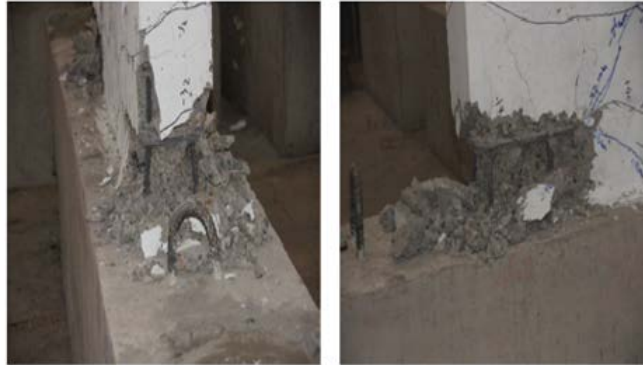
Figure 16. Concrete in the compression zone at the later stage of XJ16

Third, plasticity and softening stage: after entering the displacement loading control, with the increase of horizontal load, the speed of crack extension gradually accelerates and the width of crack increases. When the level is loaded to 520kN, a small amount of crisp has been found at the bottom. The concrete protective layer on the outside of the steel bar is shedding. After the steel bars yield, the deformation is produced under the continuous overlying action, but the compression zone of the concrete is basically intact. When the level is loaded to 570kN, the maximum crack has reached 4.5mm at this time. Immediately, there was a collapse at the bottom. The steel is exposed. The obvious bending phenomenon was found. At this time, the plastic coefficient of the specimen is about 5, and the ductility is basically good.

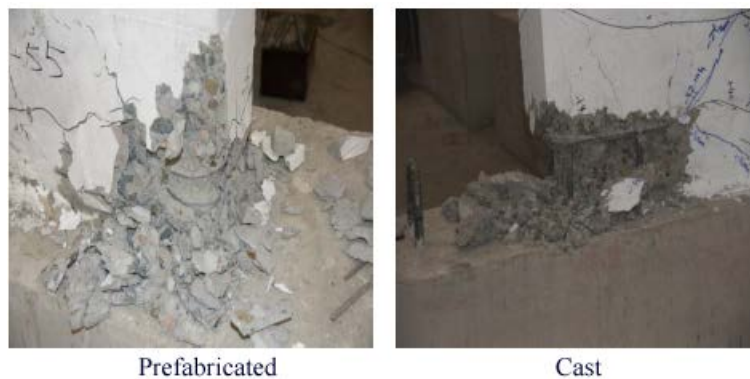
(1) The confined zone of cast - in - situ concrete shear wall is confined only by rectangular stirrup. The precast concrete shear wall not only has the constraint of the rectangular stirrup, but also the internal spiral stirrup constraint. The test shows that the compression zone of precast concrete shear wall with spiral stirrup is only the phenomenon of crushing on the surface, and it is not destroyed inside.

Figure 19. The destruction phenomenon in the compression zone of shear wall

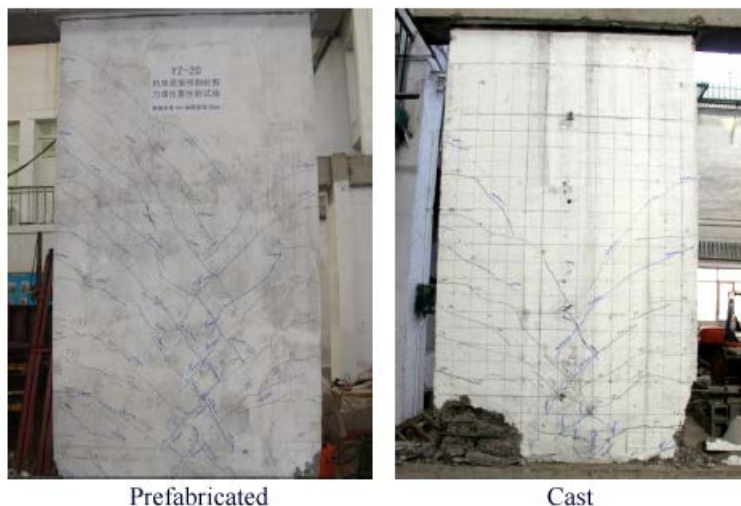
(2) The crack of precast concrete shear wall is more fully developed. For example, the YZ20 prefabricated shear wall specimens are reliable due to the lower connection. The wall is full of uniform cracks. The concrete compression zone in the middle and lower part of the XJ20 cast shear wall specimens is completely crushed. There are cracks in the wall below the height of 1/2. The crack does not extend to the upper part of the wall.

Figure 20. Development of crack in shear wall
