Study on Anti-birds Strategy of Overhead Transmission Line Based on Migration and Breeding Habits of Ciconia Boyciana in Heilongjiang Province

Gong Changhong¹, Shao Lingling²

¹State Grid Corporation of China, Xicheng District, Beijing, 100031, China ²Beijing SGITG-Accenture Information Technology Co., Ltd., Haidian District, Beijing, 100031, China

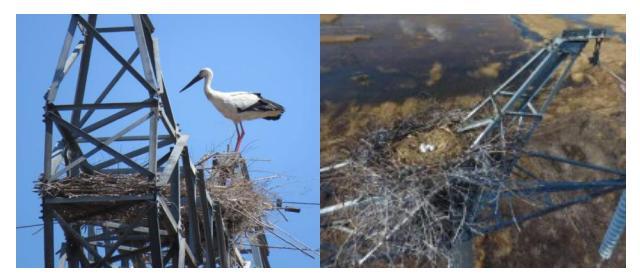
Figure 1: Oriental white storks and eggs found during patrols

In the western region of Heilongjiang Province, the border region between its southern region and Jilin Province, Qiqihar and Daqing region, the distribution of bird-related faults is concentrated, and the power lines in this area are mostly set up high overhead. Since the 18th CPC National Congress, the government has vigorously promoted the construction of ecological civilization, and the ecological environment in Heilongjiang Province has been improving year by year. With the increase of protection efforts, the wildlife resources in Heilongjiang Province have been continuously enriched. In particular, the number of large birds such as oriental white storks has increased significantly due to the improvement of their living environment and the promotion of protection levels. Since the power line tower is the main choice for its nesting, the power line fault caused by the oriental white stork has become the biggest hidden danger to the safe operation of the power grid in Heilongjiang Province in recent years. The oriental white stork and eggs found during patrols are shown in Figure 1.

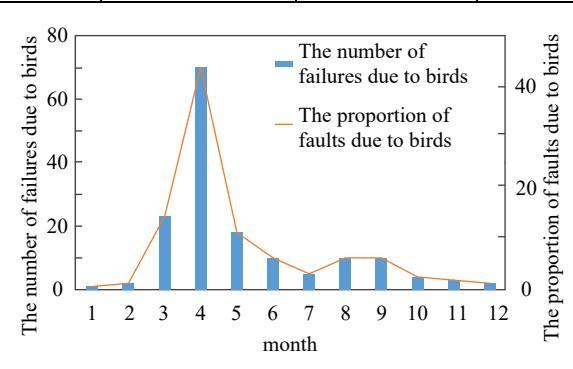
Figure 2: Monthly statistics of bird-caused fault

Statistics show that there were 125 trip-outs caused by bird activities in Heilongjiang from 2011 to 2021, including, classified by voltage level: 20 trip-outs of 500kV transmission line, 80 trip-outs of 220kV, and 25 trip-outs of 110kV; classified by the fault type: 108 trip-outs caused by bird droppings, 7 trip-outs of short-circuit caused by bird's body contact, and 10 trip-outs caused by bird nest. A total of 38 species of birds were observed, including 6 rare species. The results show that when the height of crossarm on the pole is less than 25m or more than 35m, the incidence of bird-caused fault is obviously reduced; when the height of upper crossarm is in the range of 25~35m, bird activity is obvious, and bird-caused faults are more likely to occur, where the main fault type is bird droppings. Avoiding faults caused by bird droppings should be the key direction of bird prevention strategy in Heilongjiang Province. The information and monthly statistics of bird-related faults are shown in Table 1 and Figure 2.
